3. EVALUATION OF OU 3-14 CONTRIBUTING SOURCES

3.1 OU 3-14 Soil Contamination Sites

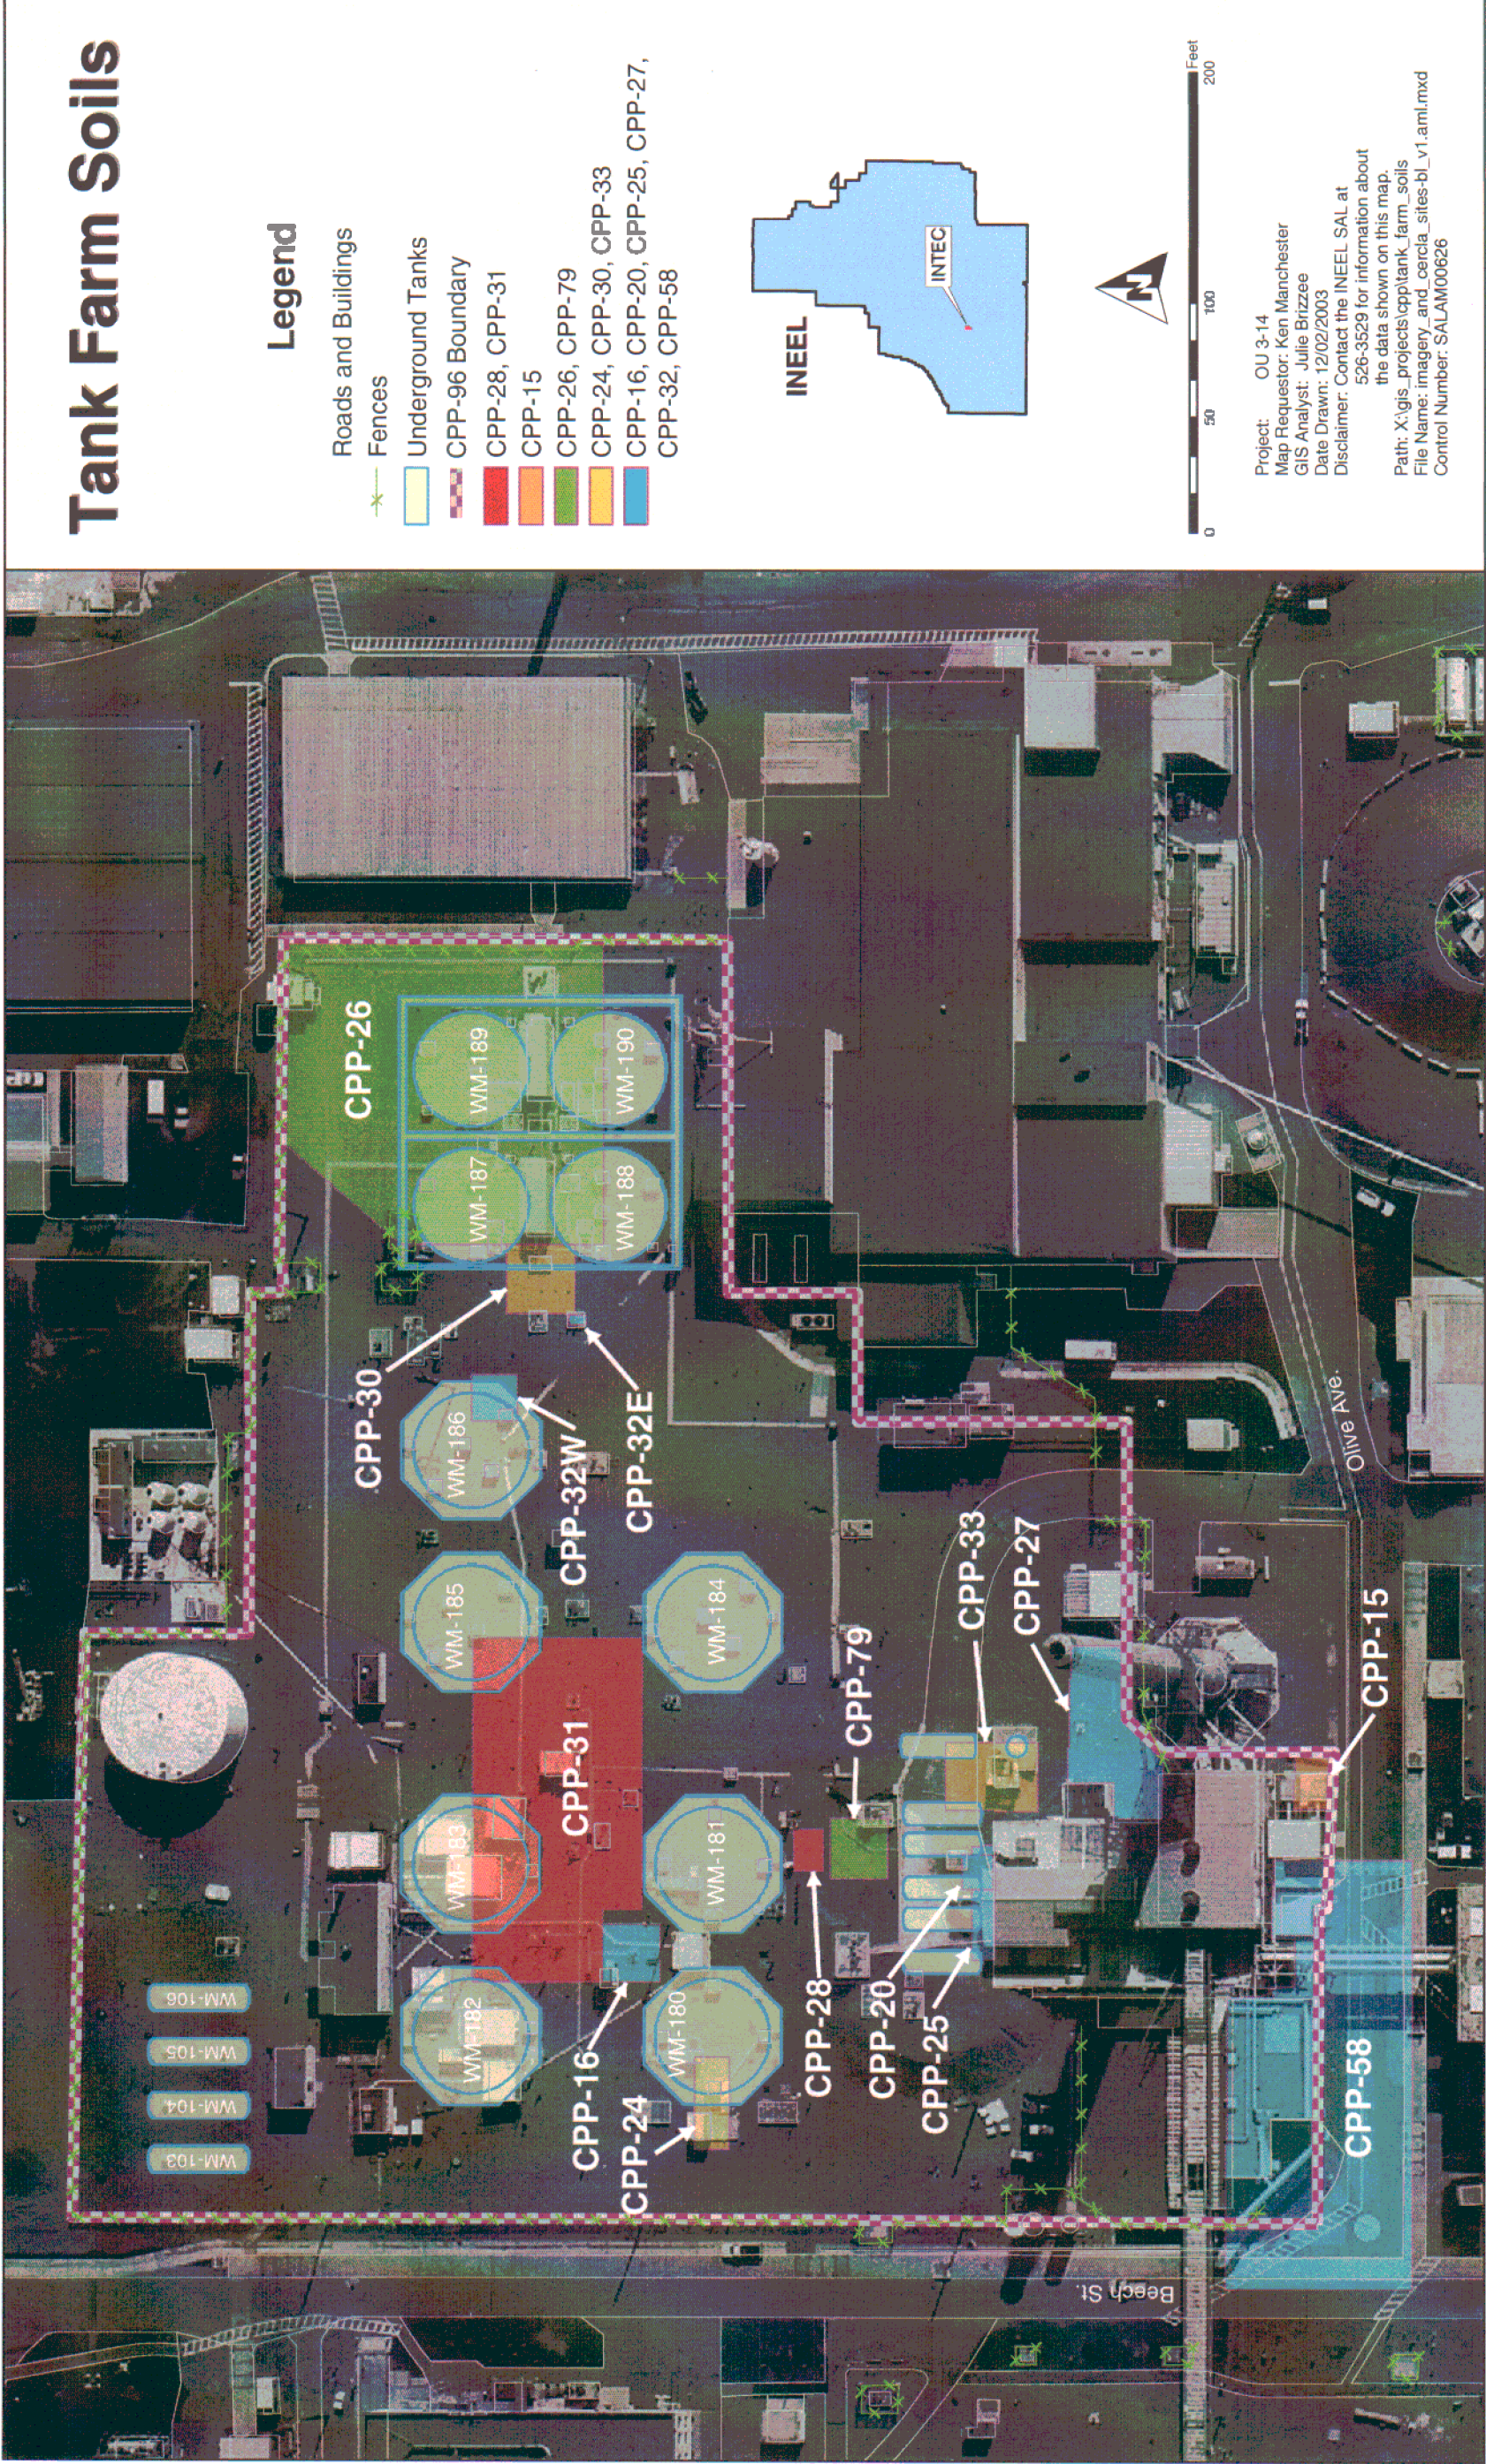
Contamination in tank farm soil resulted from past spills, leaks, and contaminated backfill. Spills have occurred during waste-handling and maintenance operations at the tank farm. Many of the leaks are from incompatible piping that corroded due primarily to contact with acidic waste. The time, duration, and volume of the releases are difficult to determine in some cases. Backfill with relatively low amounts of contamination was sometimes used during tank farm maintenance and contamination removal activities. Typical materials used to backfill tank farm excavations consisted of contaminated soil with

Figure 3-1. Known tank farm soil contamination sites.

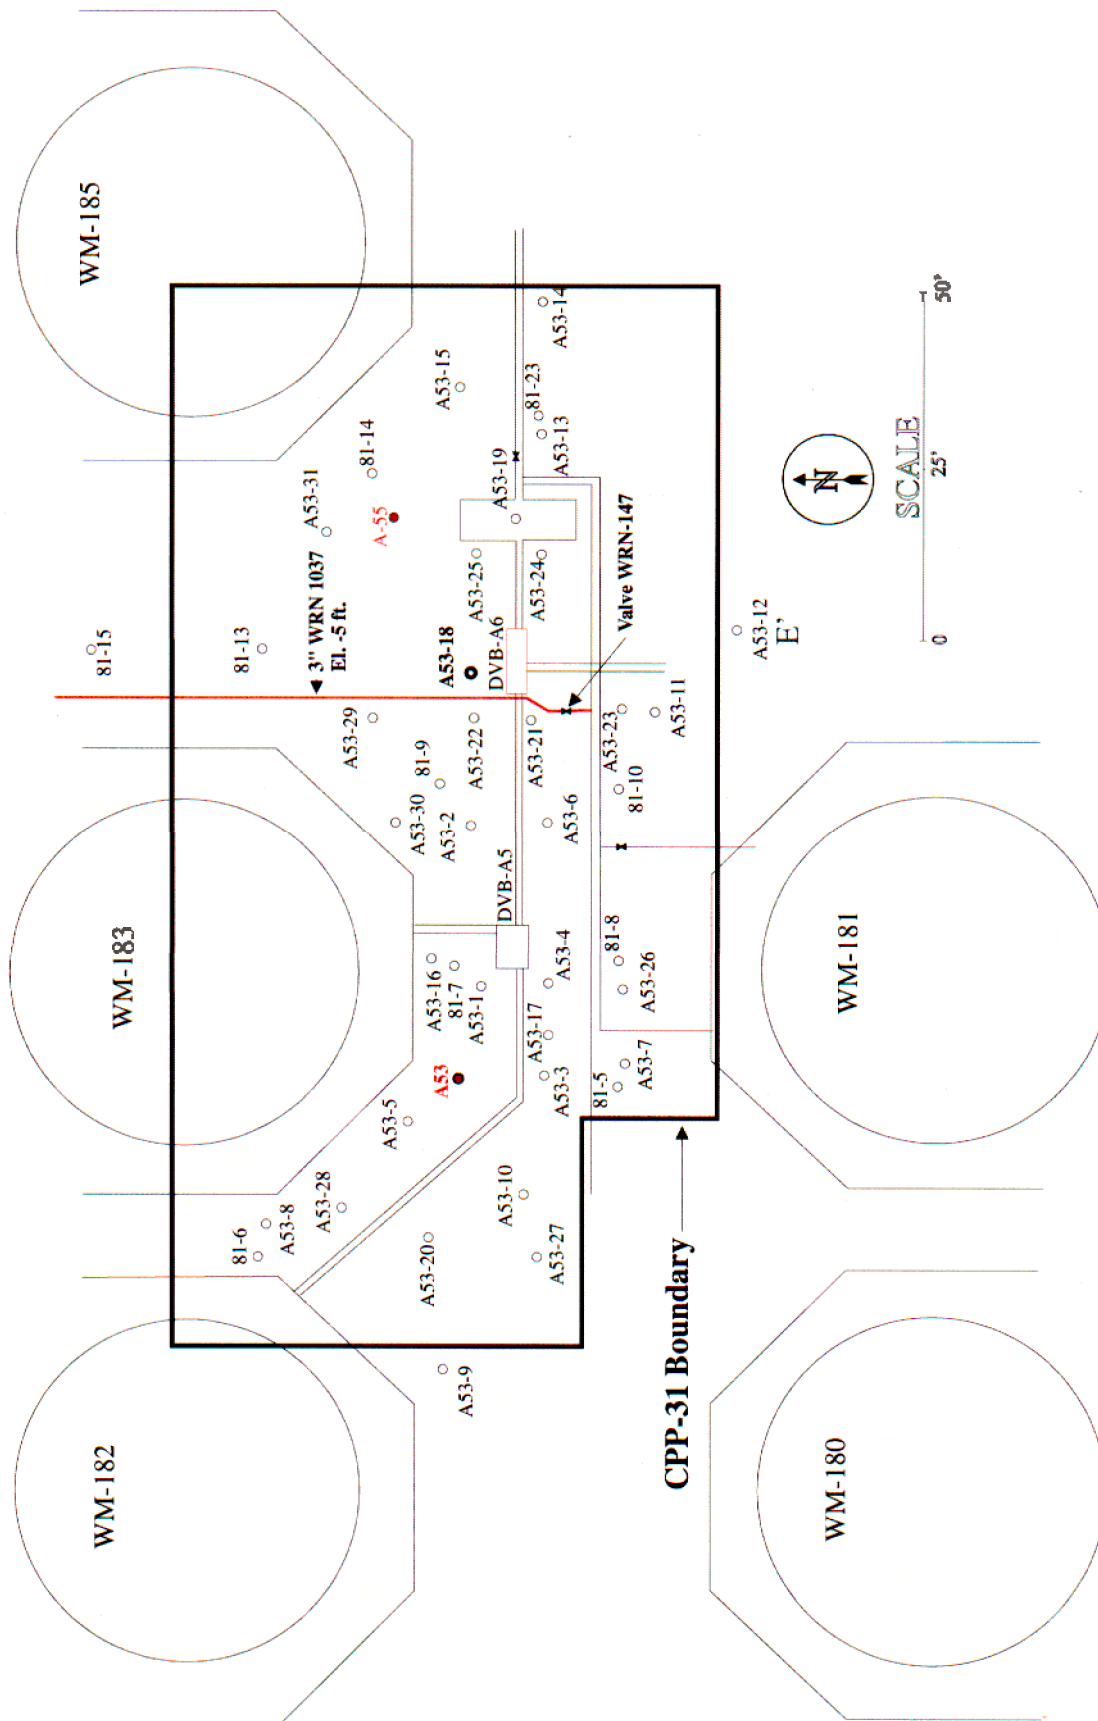
In September 1975, 10 additional monitoring wells (A-50 through A-59) (Figure 3-3) were drilled and installed to extend the monitoring network to the older part of the tank farm. On September 18, 1975, while drilling monitoring well A-53, located approximately 15 ft southwest of tank WM-183 and 10 ft south of the edge of the tank vault (Figure 3-3), contaminated soil was brought to the surface. Beta/gamma radiation levels in the auger drill cuttings reportedly ranged from 100 mR/hr at 15 ft bgs to 500 mR/hr at 22 ft bgs. A radiation profile was taken by lowering a radiation detector into the hollow-stem augers. Readings greater than 10 R/hr were measured at depths of 14, 18, 19, and 23 ft below grade. Well A-55, located southwest of WM-185, also encountered contaminated soil but at lower concentrations than A-53.

Fifteen additional exploratory holes (A-53-1 through A-53-15) were drilled to a depth of 25 ft by the USGS to define the limits of the contaminated area. Soil samples and a radiation measurement plot were collected from each hole. These holes were not cased and were backfilled as the bit was removed. Contaminated soil was encountered in nine of the 15 holes (A-53-1, -2, -3, -4, -5, -6, -10, -13, and -15). Sixteen additional soil probe pipes (A-53-16 through -31) were driven into the ground between early

Figure 3-3. CPP-31 release site boundary and locations of monitoring wells and soil probes in and around the release site.

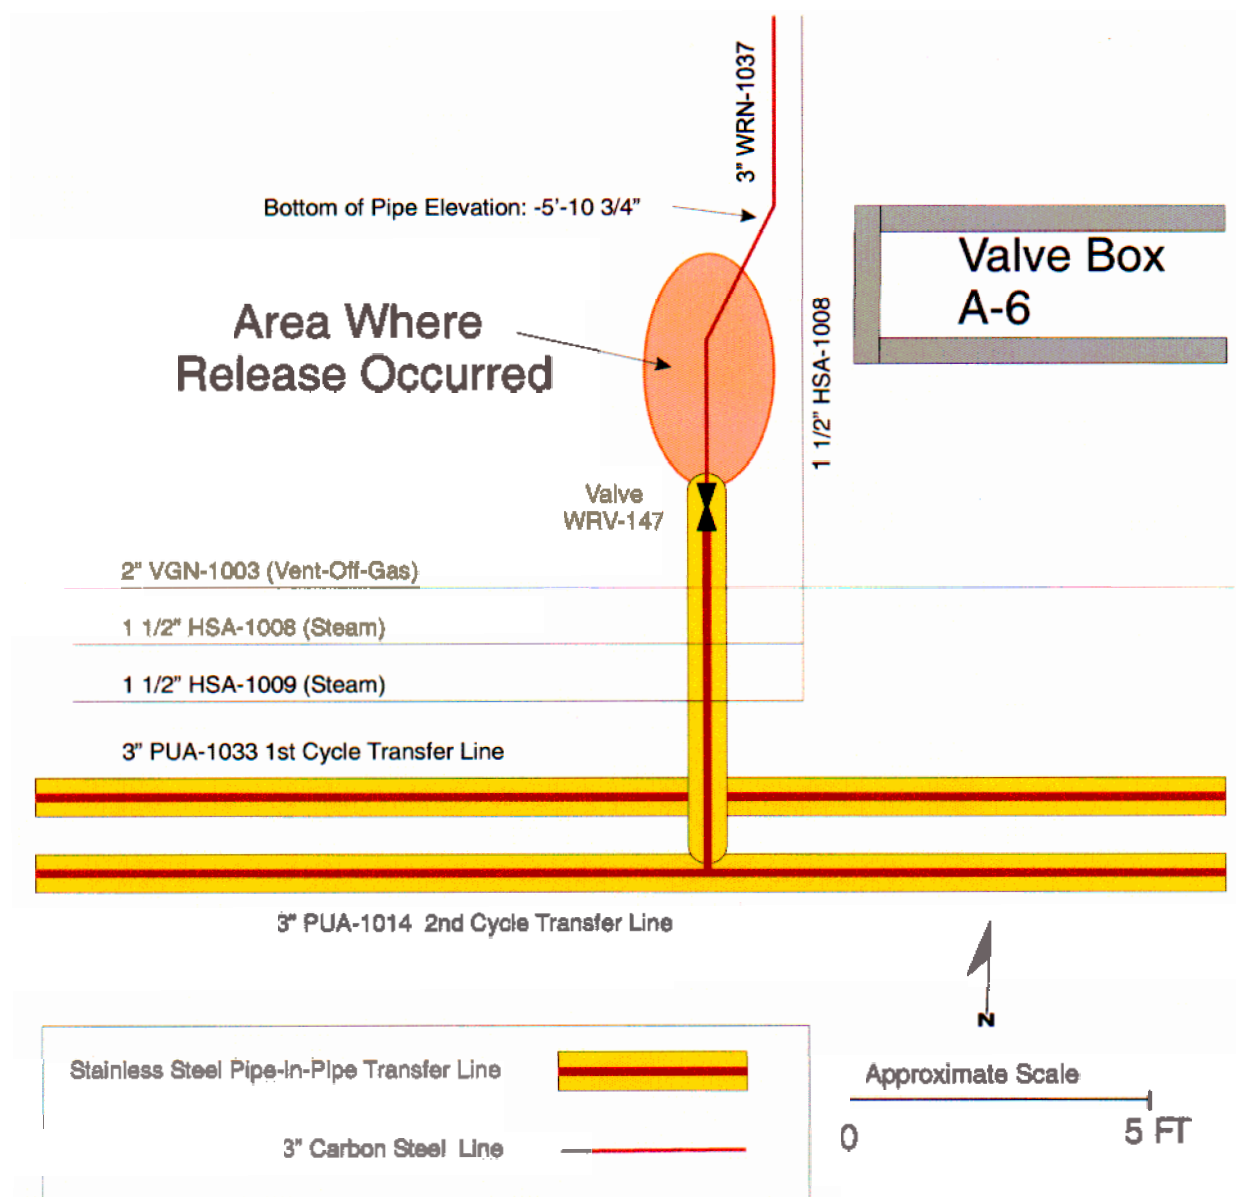
Figure 3-4. Plan view of the piping configuration at the CPP-31 release site.

the two lines. The 3"WRN1037 carbon-steel line, originating in building CPP-628, was originally plumbed into the waste-handling system as a means of discarding cooling water circulating in a closed-loop system in the event that it became contaminated due to a tank cooling coil leak. The line, which was disconnected and blinded off in building CPP-628, was pressure-tested against the closed valve. The line failed to hold pressure. It was presumed that the carbon-steel line came into contact with waste that was highly corrosive to carbon steel.

On December 11, 1975, the junction of 3"WRN1037 and 3"PWA1014 was uncovered, and on December 16, 1975, the stainless-steel line and encased portions of drain line were cut and capped. Pressure tests were applied to both the stainless-steel portion of the abandoned line to determine whether valve WRV-147 could have leaked in the closed position and the intermediate waste-transfer line 3"PWA1014. Both tests maintained pressure, demonstrating that those lines were not leaking. No further field work was conducted, and the investigation concluded that valve WRV-147 was open or partially open during one major liquid waste transfer in November 1972, when the contents of WM-181 (PEW bottoms and second- and third-cycle waste) were transferred to WM-180. The records show that about 271,000 gal of waste was transferred from WM-181, and approximately 265,000 gal were received in WM-180; this is 6,000 gal less than was sent. Taking jet dilution into account, the volume reaching WM-180 should have been about 8,000 gal greater than was transferred out of WM-181, resulting in approximately 14,000 gal backing through valve WRV-147 to the corroded carbon-steel line and into the soil.

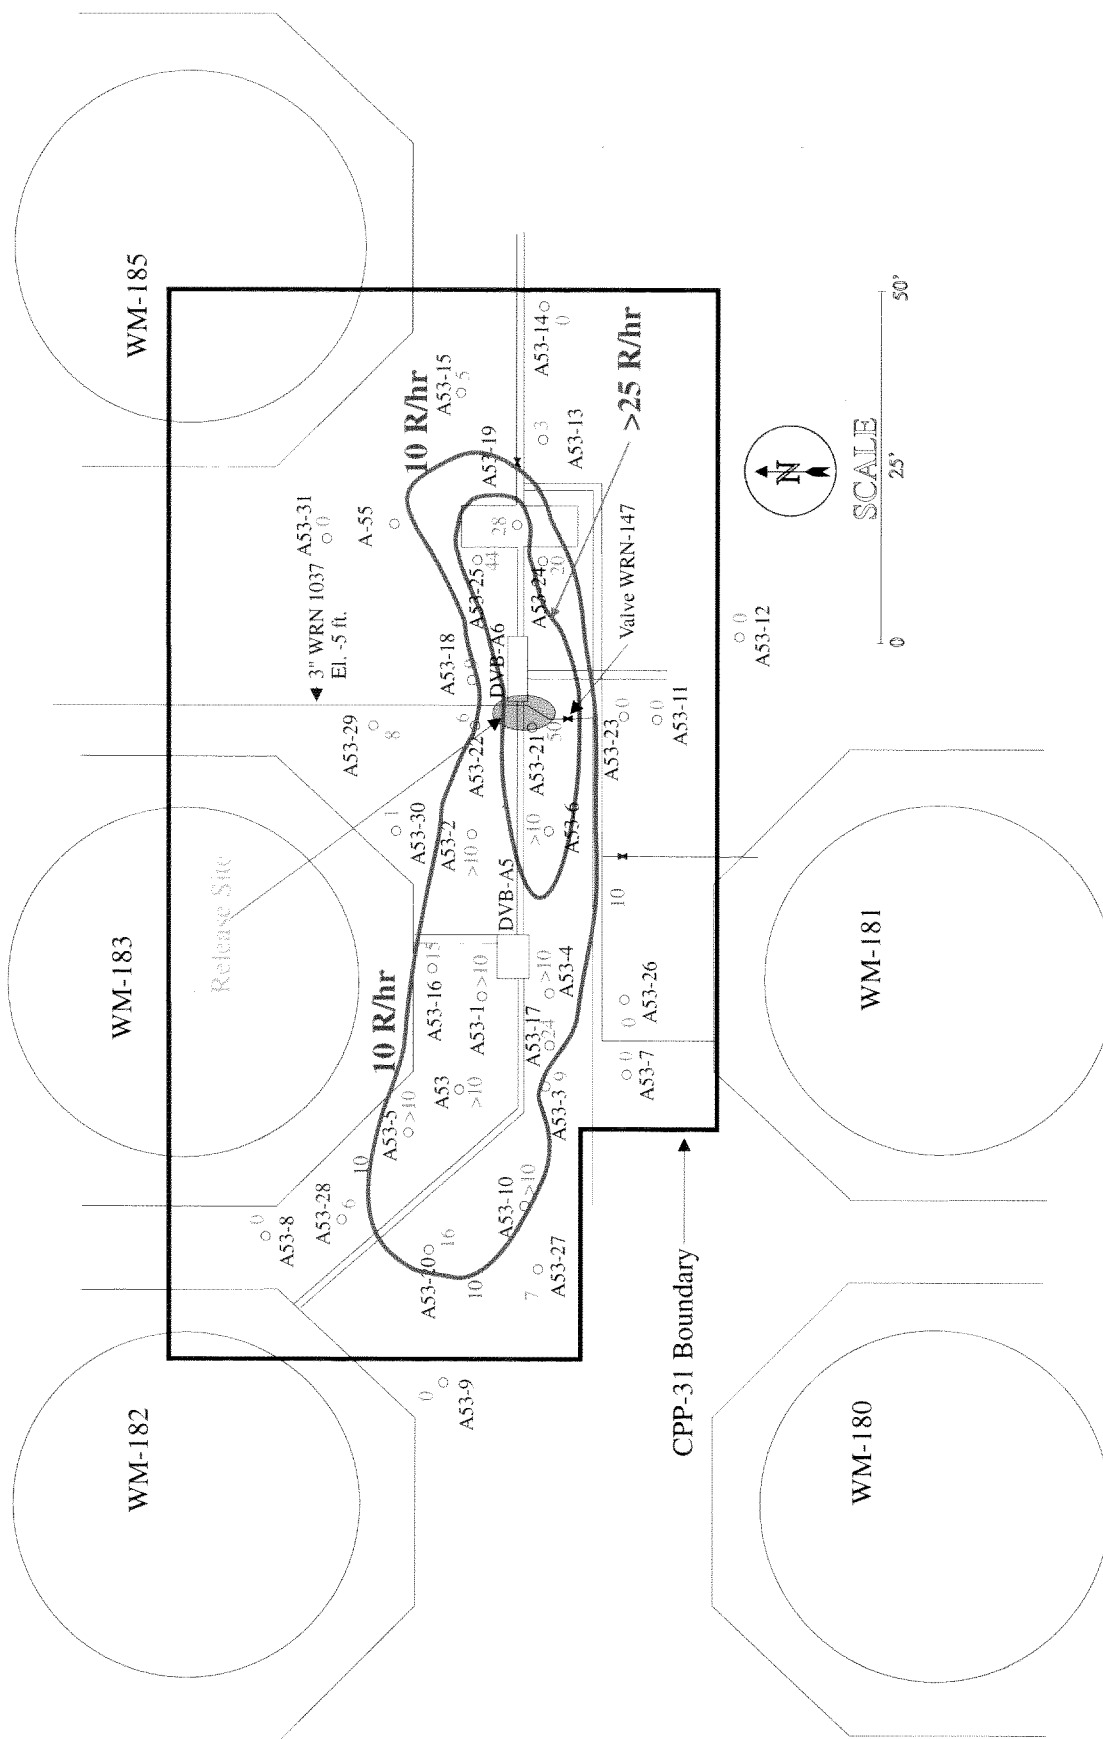
Based on the number of monitoring wells installed and their associated radiation profiles, the lateral and vertical extent of the contaminated soil appears to be adequately bounded, with the exception of a small area east of valve box A-6 along the piping runs of 3"PWA-1005 and 3"PWA-1030. Monitoring well A53-25 encountered contaminated soil but did not penetrate the vertical extent of contamination at that location. However, based on reviews of data from other probes, the contamination likely extends no deeper than 25 ft bgs, leaving approximately 15 ft of alluvial material between the bottom of the measured contamination and the top of the basalt.

Figure 3-5. Extent of lateral contamination at the CPP-31 release site (measurements in R/hr).

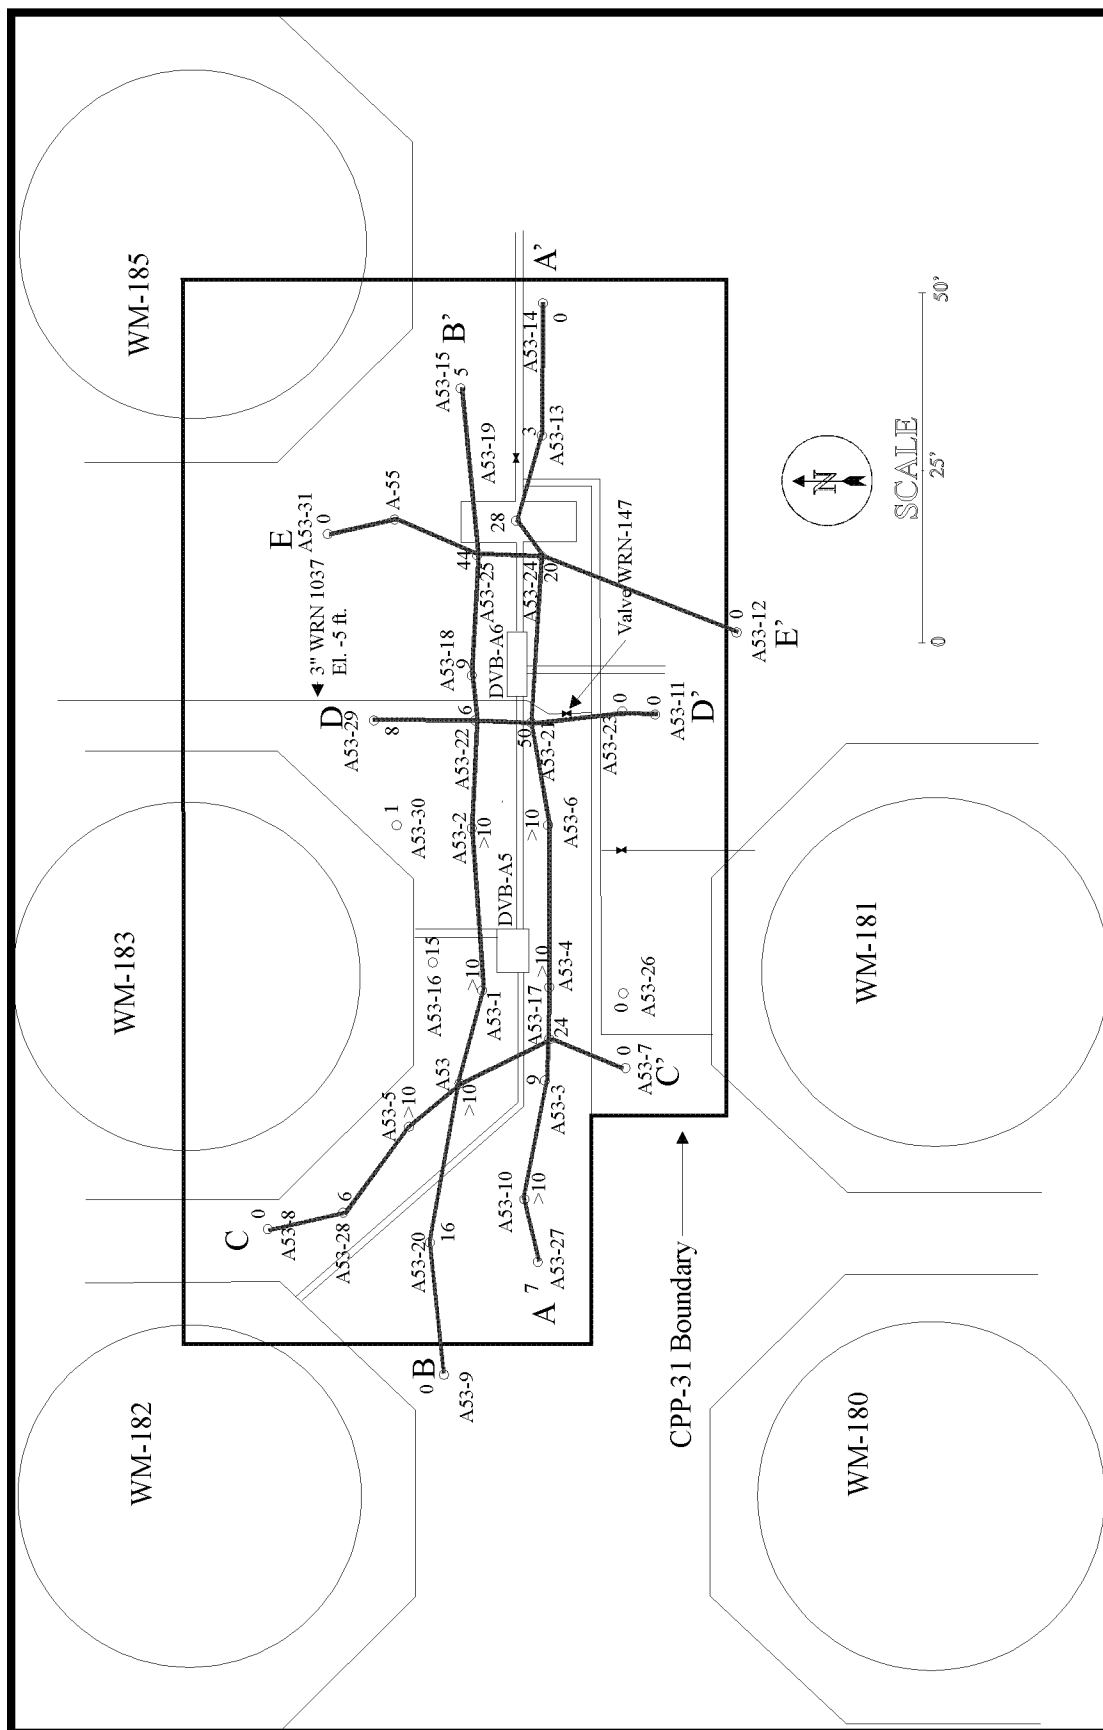
Figure 3-6. Fence diagram showing vertical and lateral extent of soil contamination (measurements in R/hr) at CPP-31.

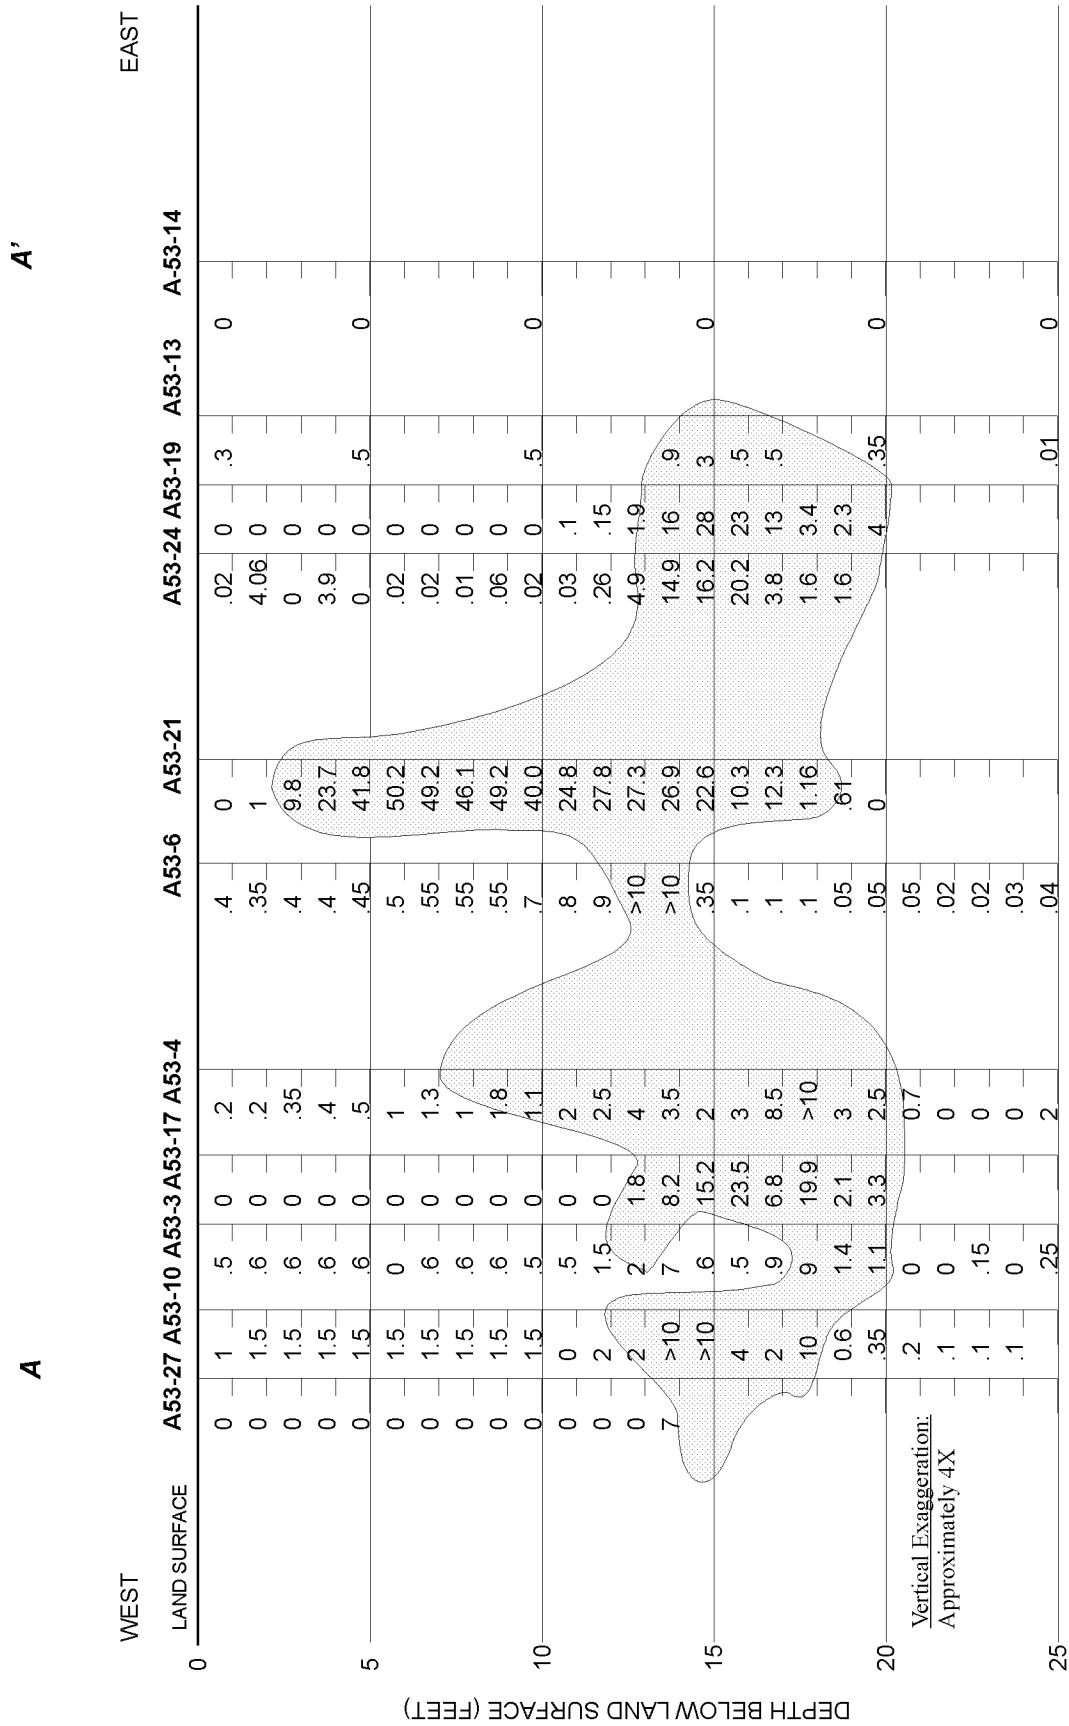
Figure 3-7. East-to-west, A-to-A', fence diagram through the CPP-31 zone of contamination (radiation readings are in R/hr; readings >5 R/hr are shown in red).

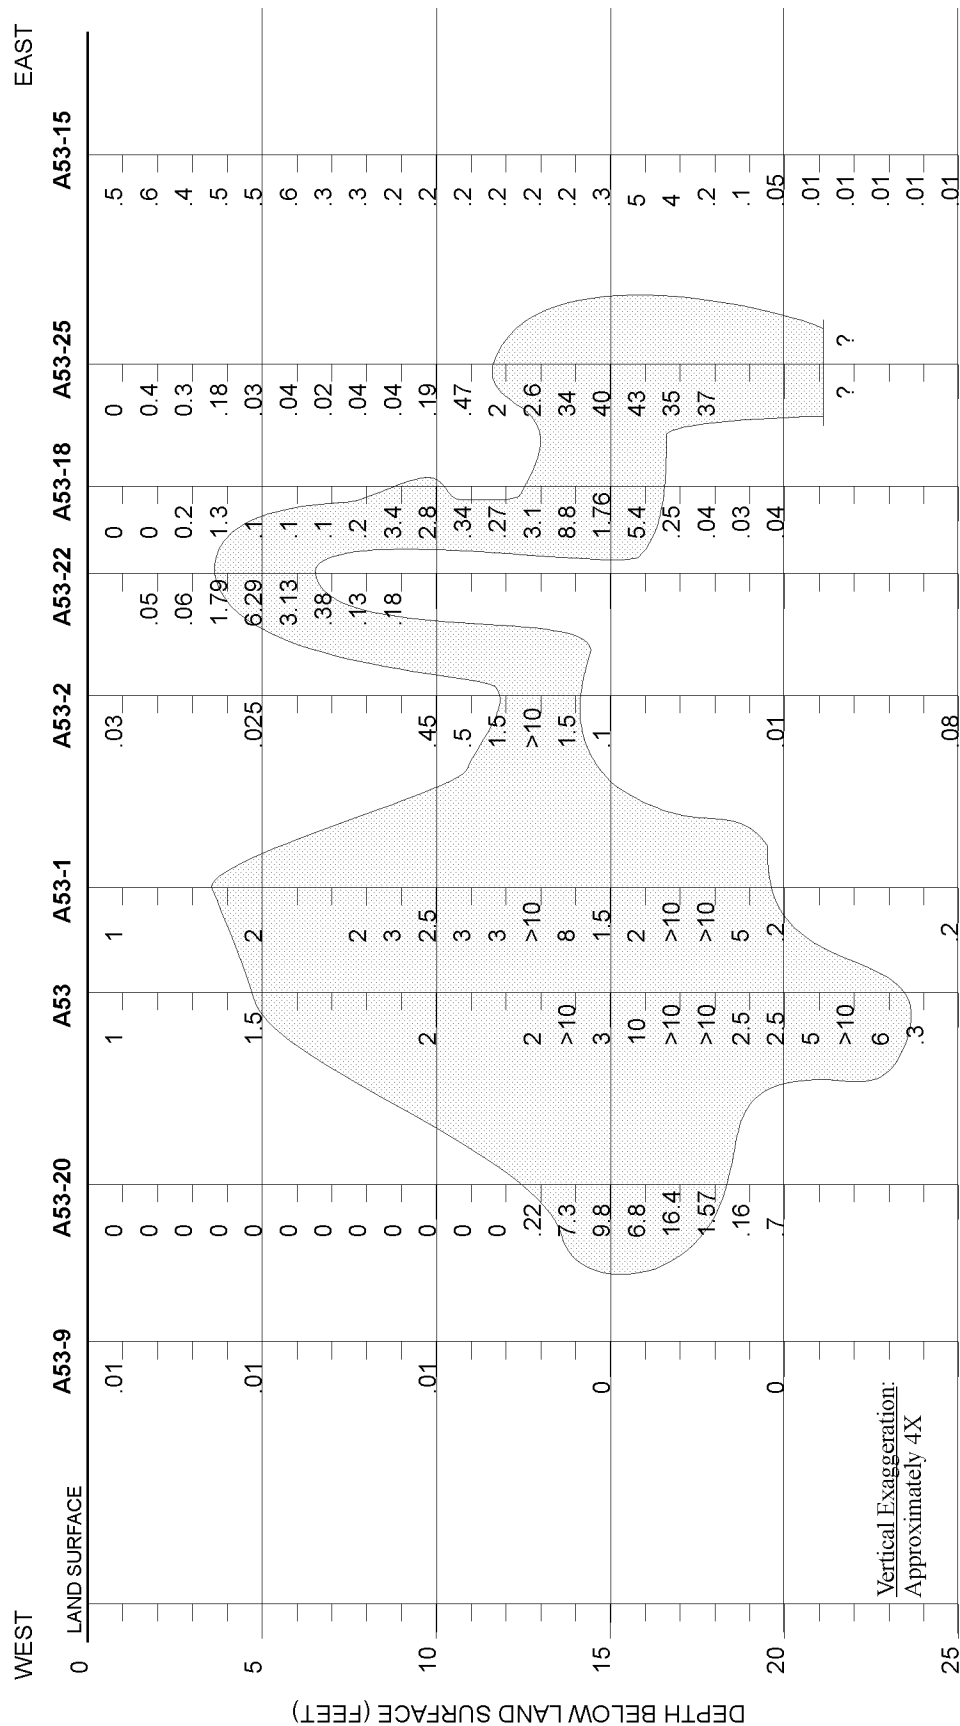
Figure 3-8. West-to-east, B-to-B', fence diagram through the CPP-31 zone of contamination (radiation readings are in R/hr; readings >5 R/hr are shown in red).

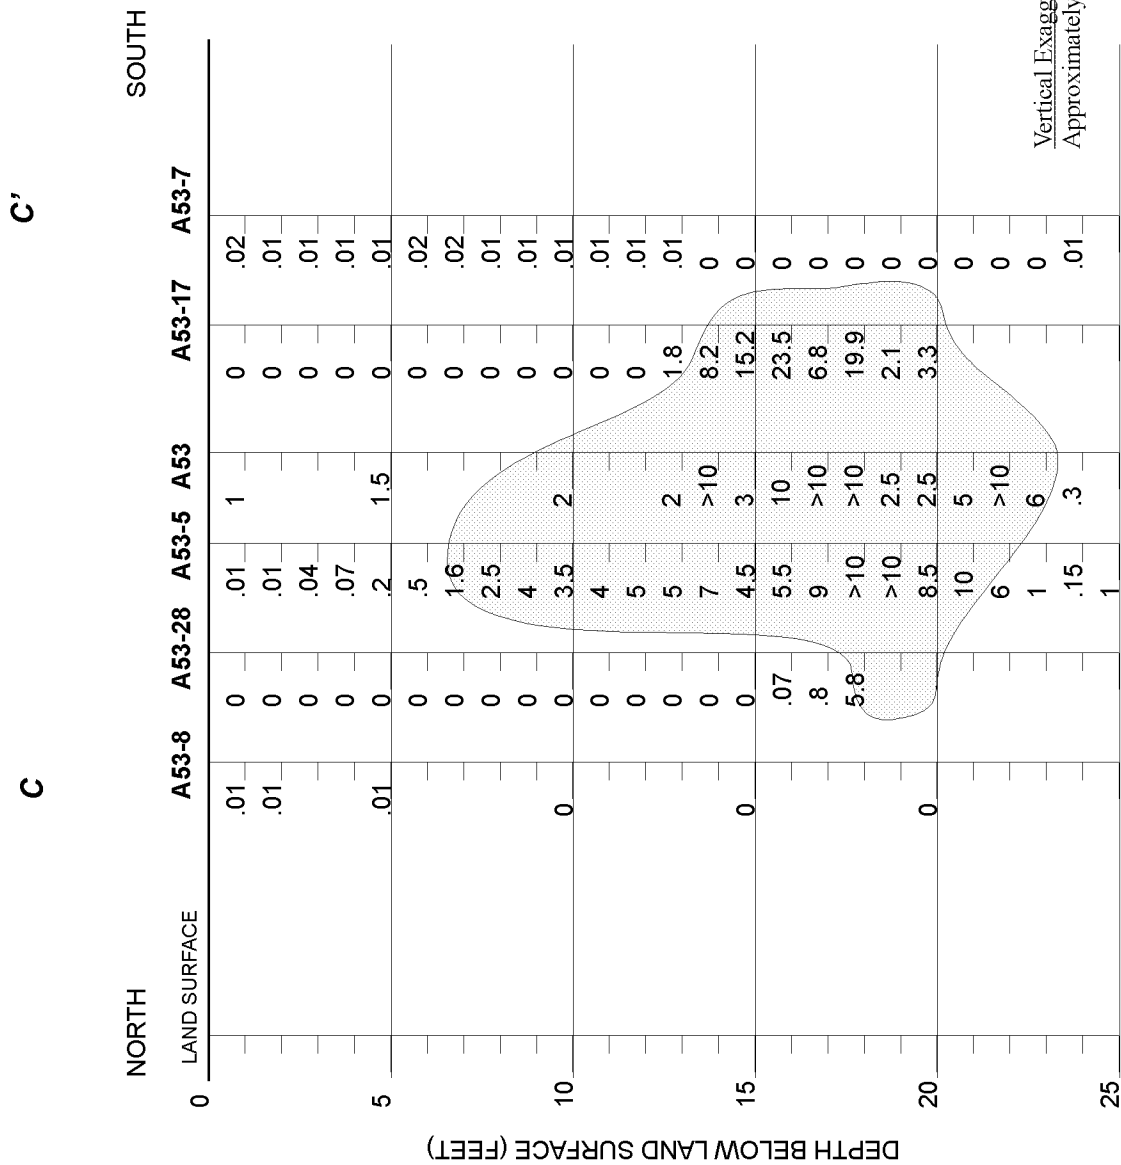
Figure 3-9. North-to-south, C-to-C', fence diagram through the body of contaminated soil at CPP- 31 (radiation readings are in R/hr; readings >5 R/hr are shown in red).

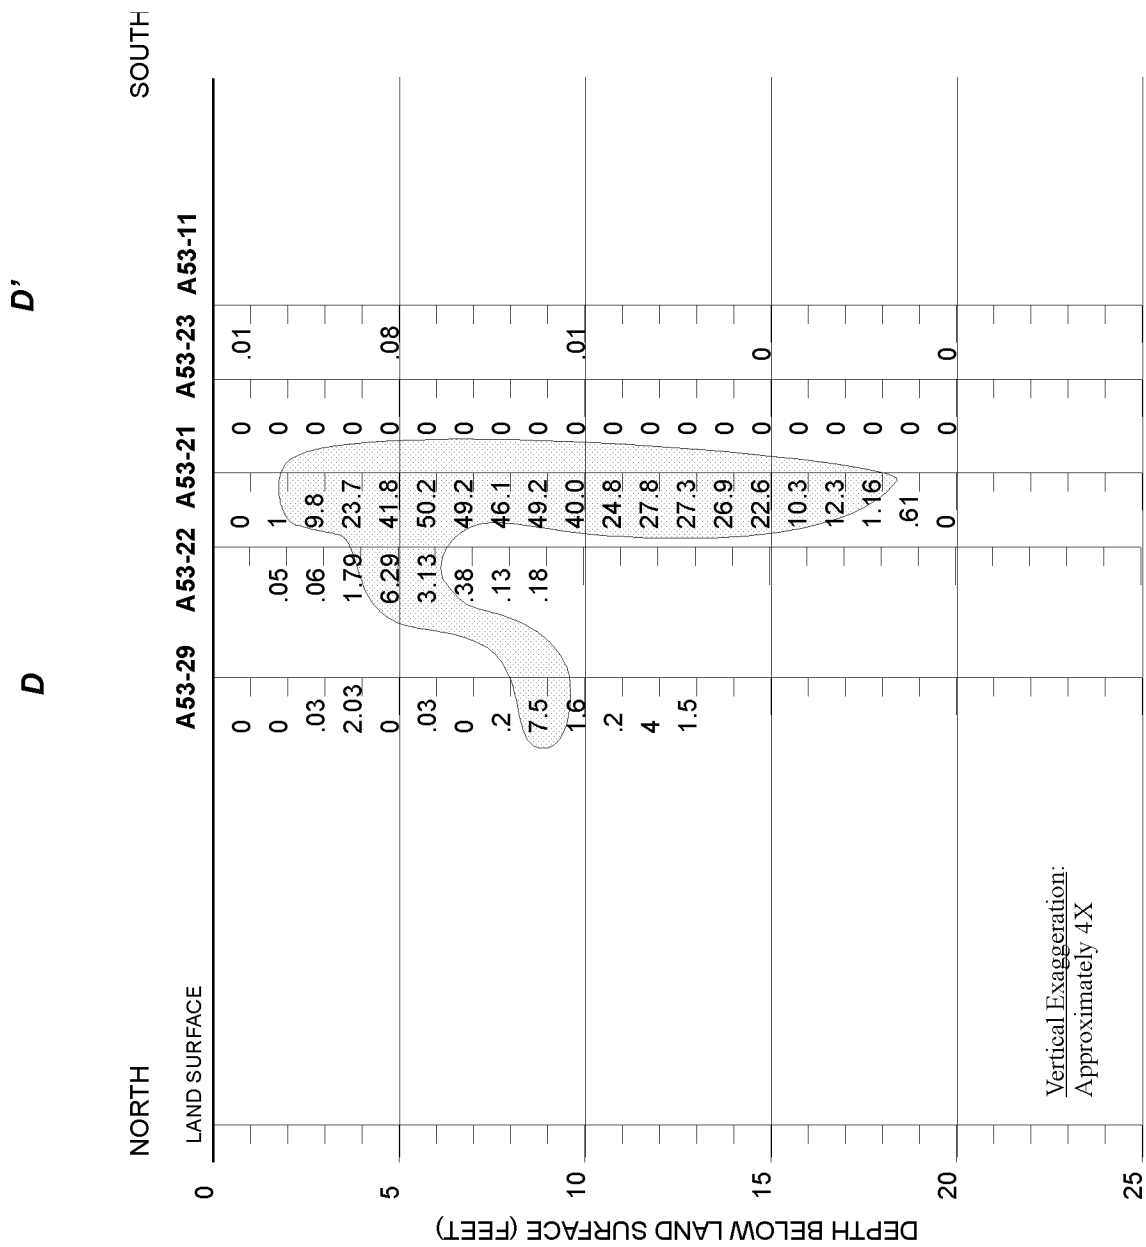
Figure 3-10. North-to-south, D-to-D', fence diagram through the body of contaminated soil at CPP-31 (radiation readings are in R/hr; readings >5 R/hr are shown in red).

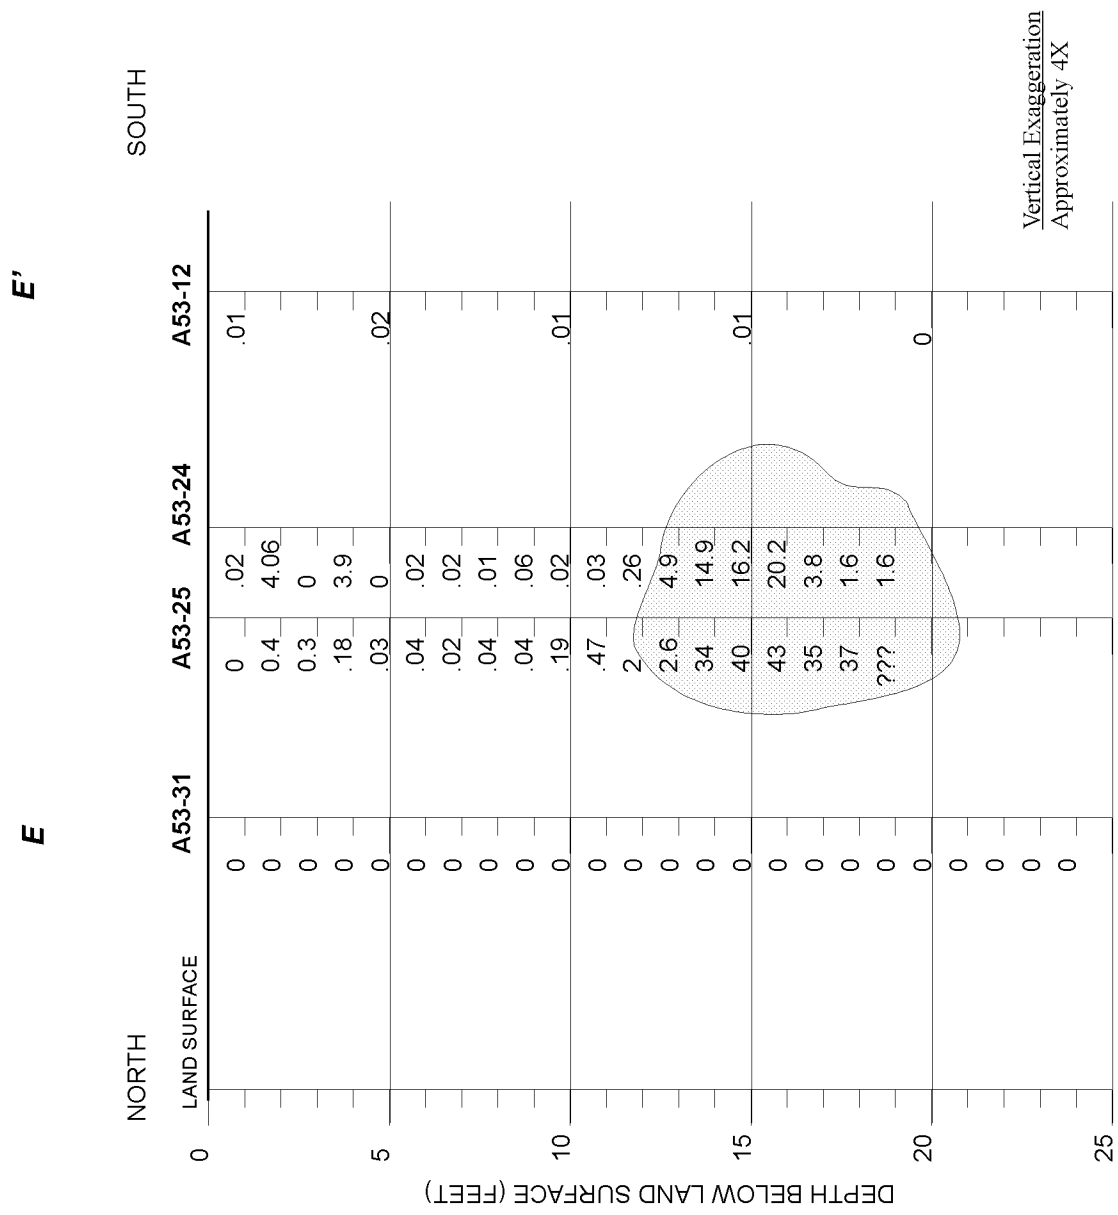
Figure 3-11. North-to-south, E-to-E', fence diagram through the body of contaminated soil at CPP-31 (radiation readings are in R/hr; readings > 5 R/hr are shown in red).

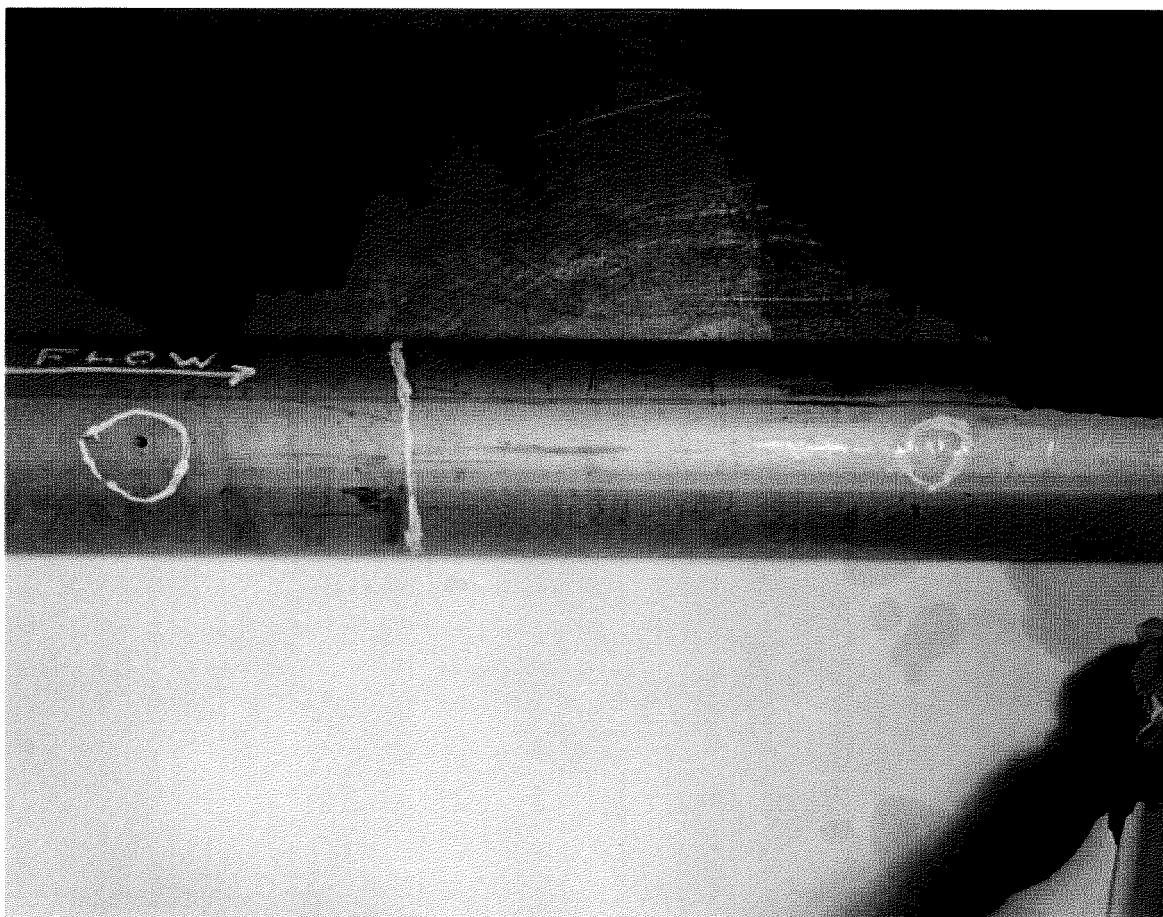
On December 3, 1974, work began to cut, remove, and inspect the 20-ft section of the waste-transfer line to determine the cause of the contamination. After removal of the pipe section, a cursory inspection revealed a 1/8-in.-diameter drill hole in the side of the 3-in. stainless-steel pipe (Figure 3-14). After closer inspection, the hole in the pipe was determined to be 10 ft, 7 in. from the east pipe cut and oriented 90° from the top of the pipe on the south side as originally installed. This location corresponded closely with the location of the corroded area of the upper section of carbon-steel encasement observed in the field. The hole penetrated completely through the pipe wall, and small indents 40 to 50 mils deep existed along the pipe on 1-ft centers eastward from the hole. No holes or indents were found on the opposite (north) side of the pipe. The hole and indents were consistent with the stitch screw spacing used to hold the top cover of the encasement to the bottom trough. A metallurgical inspection indicated that the pipe suffered very little corrosion damage during its 18 years of intermittent service and that the failure was strictly due to a hole that had existed when it was inadvertently drilled into the waste line during construction from 1955 to 1956.

Figure 3-14. Drill hole found in waste-transfer line 3"PWA-1005 at CPP-28.

The position of the hole was such that no leakage could occur unless the waste-transfer line was at least one-half full of solution. This condition occurred only when pertinent block valves (valve box A6, etc.) in the waste transfer system downstream from the hole were closed during liquid waste transfer through the pipeline. The 3-in. line was not a pressurized line and instead used gravity drainage to transfer waste to the storage tanks. Normally, with diversion block valves in their proper open settings, solution transfer flow rates were insufficient to fill the 3-in. pipeline to the 50% full level. By design, any waste leaking through the hole should have been contained within the split-steel secondary containment and directed into downstream collection sumps. However, inspection indicated the encasement was badly deteriorated and partially filled with soil. The damming effect of the soil in the encasement caused sufficient liquid backup and flow outward through the joints of the encasement and into the surrounding soil.
